TS-PIC-20003429S/20103429S  
November 2000

# AERIAL PHOTOGRAPHIC ANALYSIS COLGATE PAY DUMP SITE Baltimore, Maryland

EPA Region 3

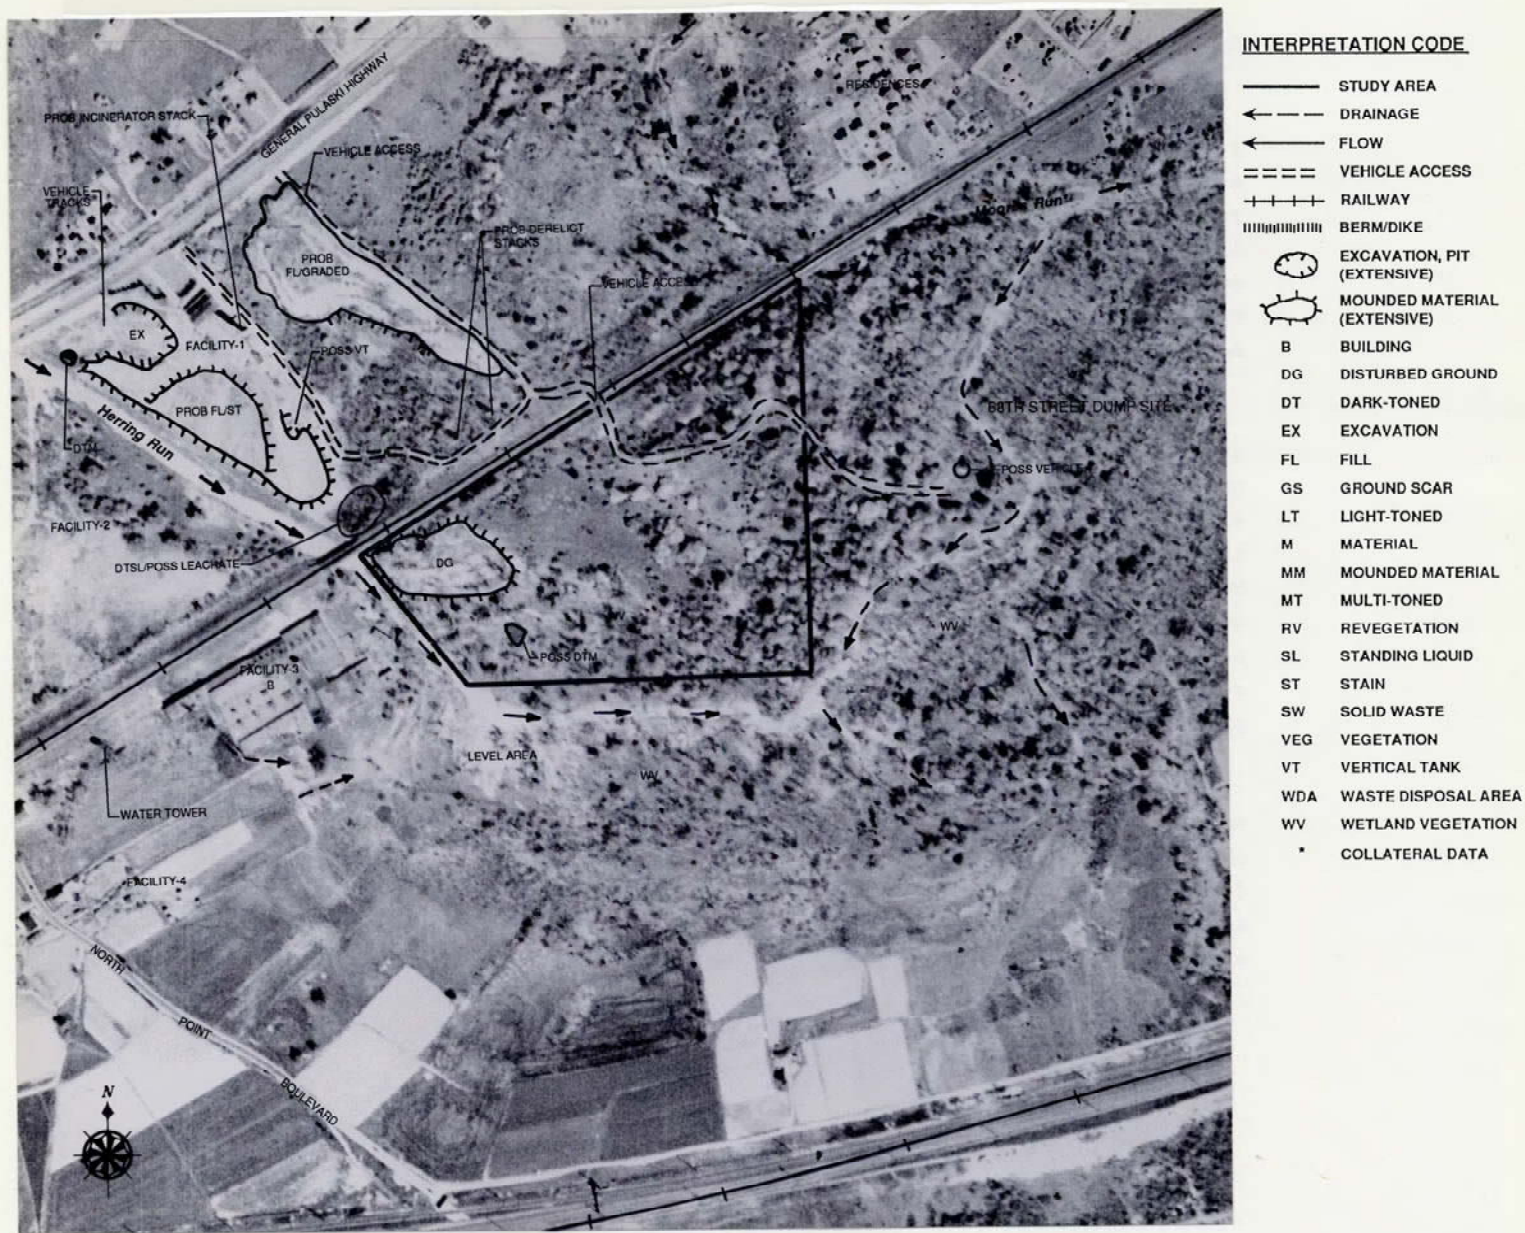
Figure 3. Colgate Pay Dump site, April 23, 1938. Approximate scale 1:4,460.

APRIL 23, 1938 (FIGURE 3)

The site is primarily comprised of undeveloped wetland vegetation (WV). A mound with disturbed ground (DG) is located in the northwestern corner of the site. An area with possible dark-toned material (DTM) is located in the southwestern portion of the site. A possible vehicle outside the eastern site boundary is near an unpaved road (annotated vehicle access\*) which extends across the northern railway.

At Facility-1 the unpaved road forks into two branches. The northeastern branch of the trail extends to the General Pulaski Highway, passing an area of probable fill material (FL) with a flat ground surface that appears both graded and partially vegetated. The southwestern branch of the trail runs near two probable derelict stacks and north of an area with dark-toned standing liquid (DTSL). It then passes north of an extensive accumulation of probable fill material with a stained ground surface (ST), a possible vertical tank (VT), an excavation (EX) containing vehicle tracks and an area with dark-toned material, and a main building (B). A probable incinerator stack is present along the eastern side of the main building. The area with dark-toned standing liquid is located at the toe of the extensive accumulation of probable fill material and is possibly leachate.

Locations for three additional facilities (Facility-2, Facility-3, and Facility-4) in various stages of development are identified west of the site. Facility-2 is essentially undeveloped at this time, while Facility-3 includes a main building and a water tower. Facility-4 is comprised of several structures (not annotated) along North Point Boulevard. Drainage from Facility-3 and Facility-4 trends downhill to the northeast toward an unbounded, level area on the southern bank of Herring Run.

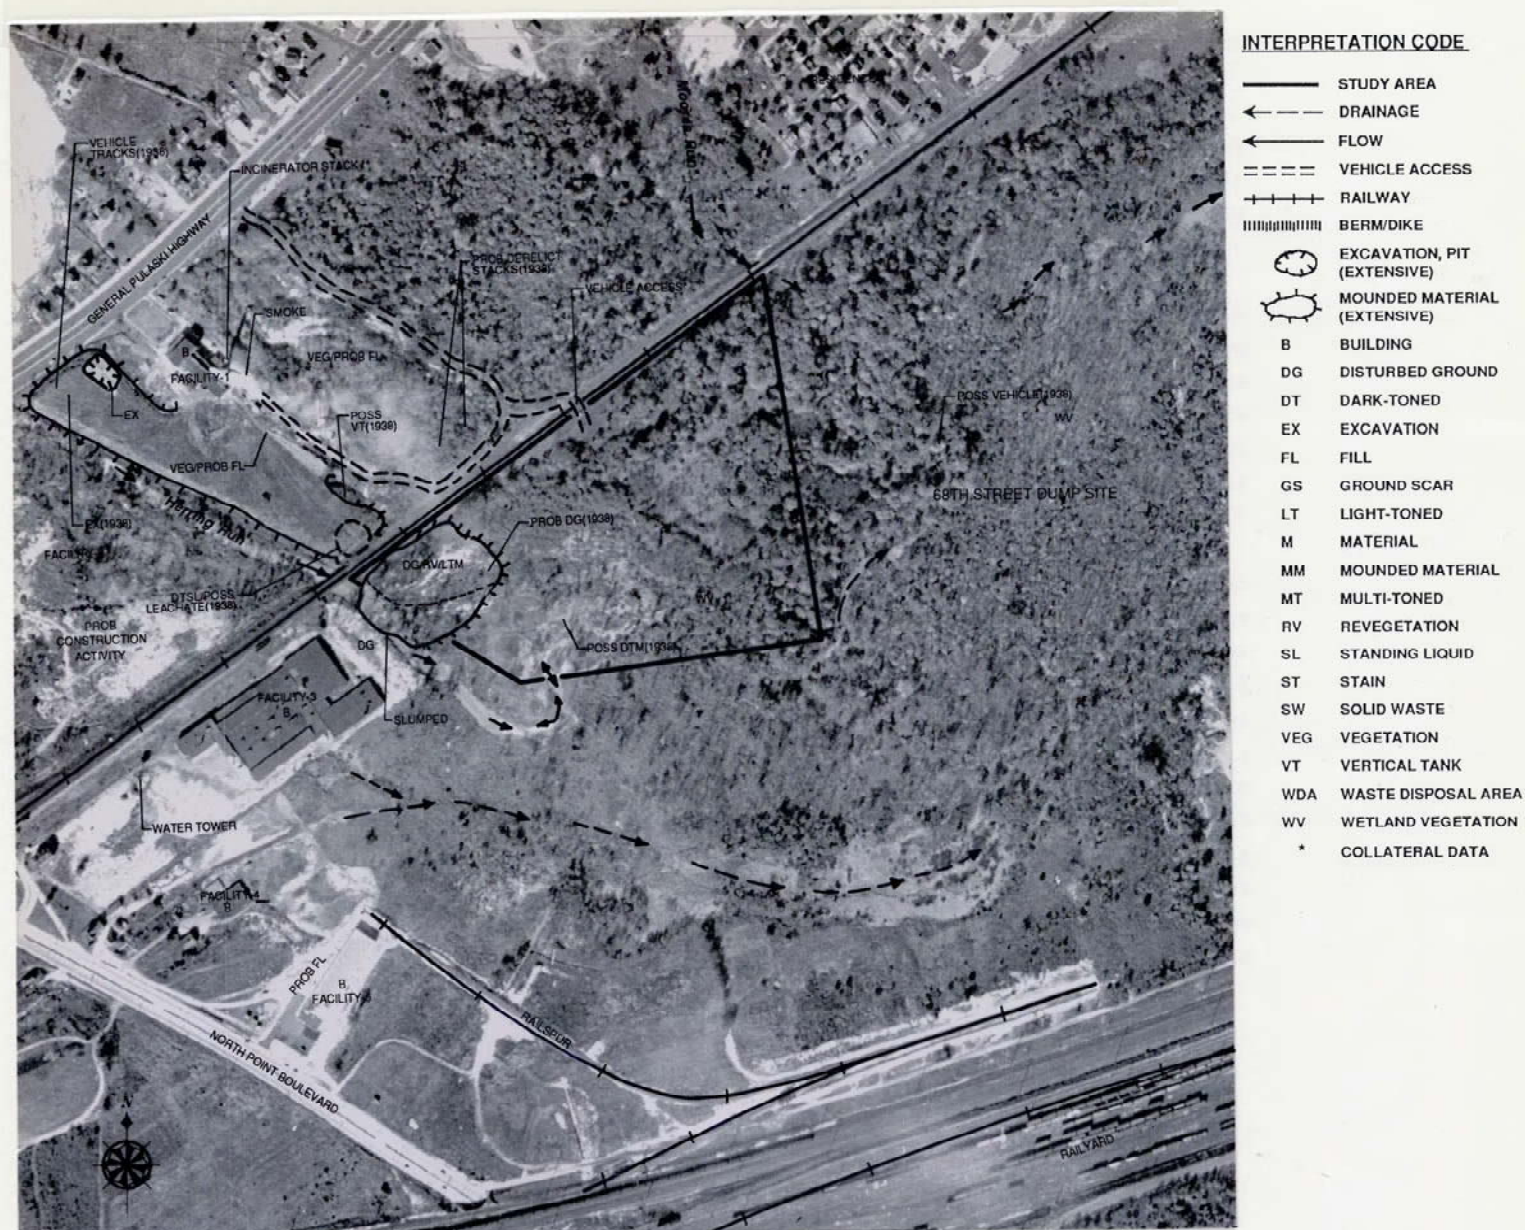
Figure 4. Colgate Pay Dump site, October 21, 1947. Approximate scale 1:5,450.

OCTOBER 21, 1947 (FIGURE 4)

The site remains undeveloped and vegetation canopy obscures some of the features observed in 1938. The southwestern portion of the disturbed ground mound appears to have slumped downhill into Herring Run. A dashed line represents the former southwestern boundary of the mound (1938). Areas of light-toned material (LTM) are visible on the revegetated (RV) surface of the mound. In the southern portion of the site, the formerly observed possible dark-toned material is not visible. Southwest of the site, North Point Boulevard has been improved.

Off-site, the probable derelict stacks observed in 1938 have been removed, and the possible vertical tank is not visible at Facility-1. The "probable" qualifier is removed from the incinerator stack, where smoke emissions are now visible. East of the main building along the northeastern branch of the trail, the probable fill area has been covered by vegetation (VEG). West of the main building along the southwestern branch of the trail, the formerly observed excavation and vehicle tracks appear to have been filled over and the surface of the stained, probable fill material is covered with vegetation. A new, rectangular excavation area is located on the northwestern side of this probable fill material.

At Facility-2 an unbounded area of probable construction activity is noted. At Facility-3 an area with disturbed ground is located along the bank of Herring Run. A main building has been installed at Facility-4. A new facility (Facility-5) includes an accumulation of probable fill next to the northwestern side of the main building. A rail spur from the southern railway extends to Facility-5.

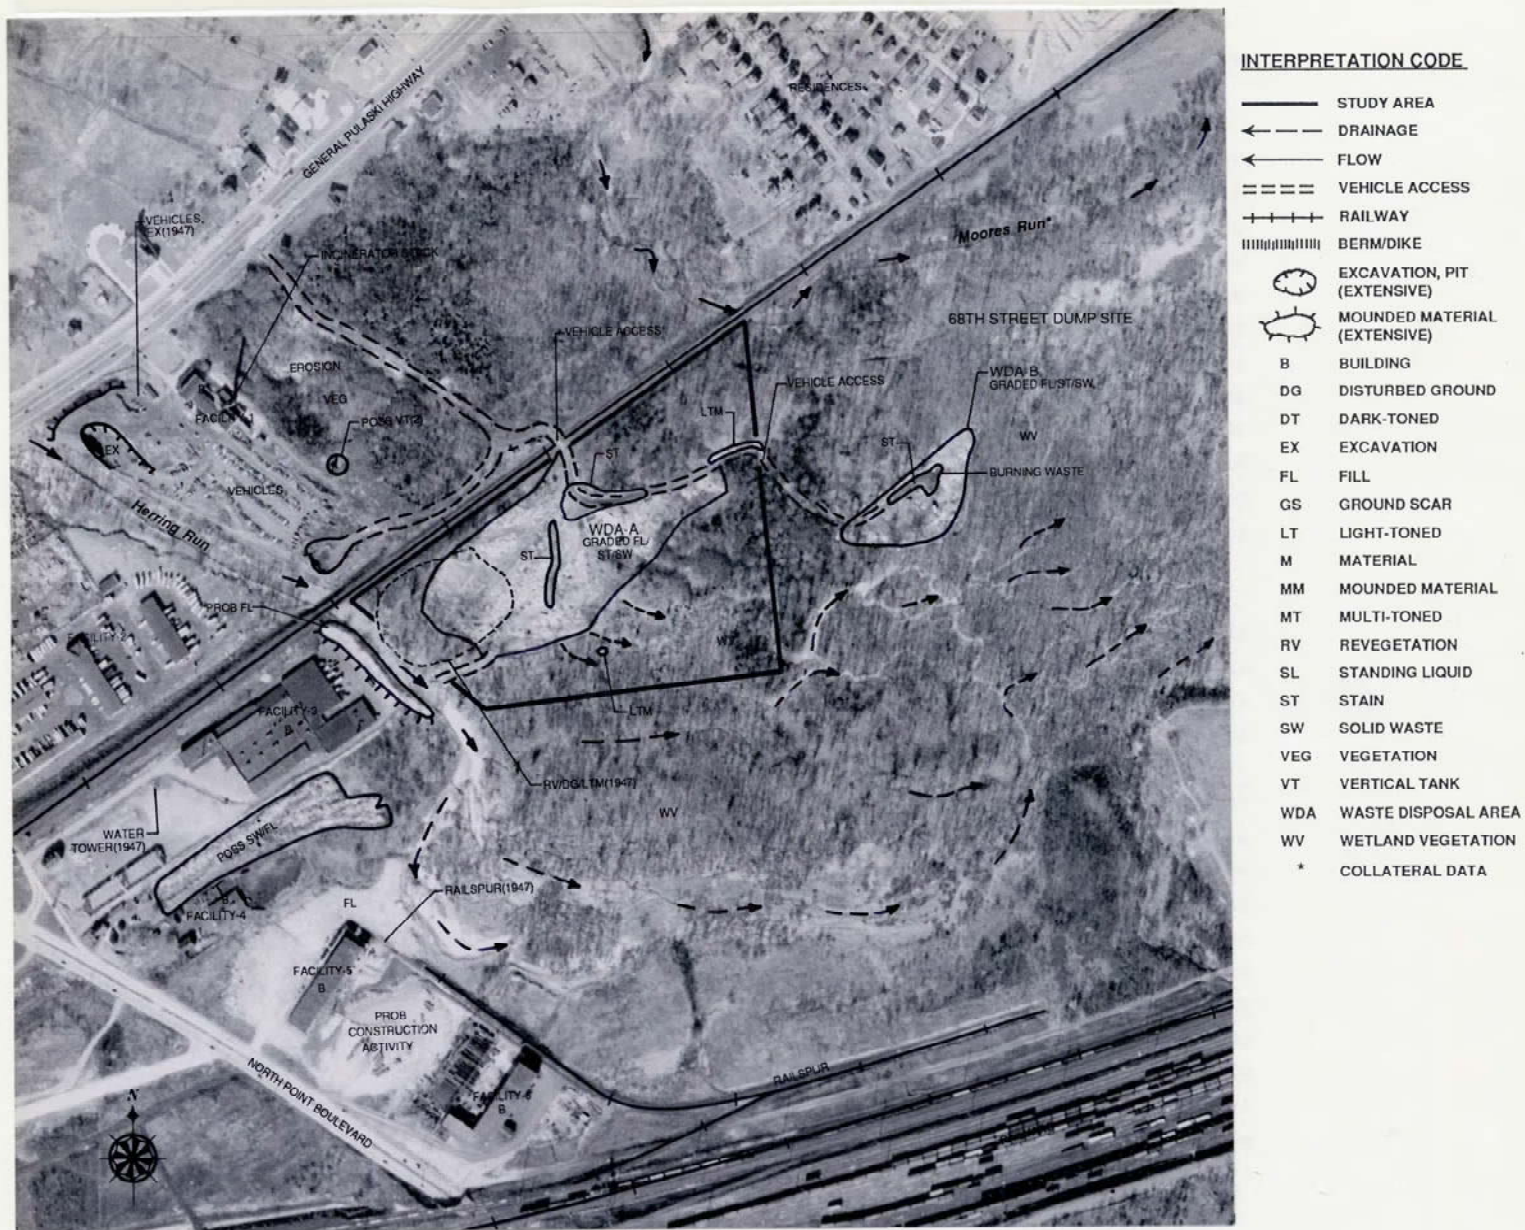
Figure 5. Colgate Pay Dump site, February 14, 1953. Approximate scale 1:4,780.

FEBRUARY 14, 1953 (FIGURE 5)

The western portion of the disturbed ground mound appears to have revegetated and the previously observed areas of light-toned material are not visible. The eastern portion of the disturbed ground mound has merged with a waste disposal area (WDA-A) where active dumping is evident.

At a waste disposal area (WDA-B) in the adjacent 68th Street Dump site, dumping is also seen and includes a stained area for burning solid waste. Both of these waste disposal areas are comprised of graded, stained fill material and scattered solid waste (SW). Areas with light-toned materials are noted within the eastern and the southern site boundaries. Unpaved vehicle access roads are present between the Colgate Pay Dump site, the 68th Street Dump site, and Facility-1.

Vehicles are parked at the former (1947) location of an excavation observed at Facility-1. East of the main building, signs of erosion are visible. West and south of the main building, extensive excavations, numerous vehicles, and two possible vertical tanks are observed. To the west, Facility-2 has been more fully developed. At Facility-3 the water tower has been removed and the area of disturbed ground along Herring Run has been replaced by a linear accumulation of probable fill material. A large accumulation of fill material and possible solid waste is located along the northern side of Facility-4. Level fill material has been added along the northern and eastern sides of the main building at Facility-5. There is an area of probable construction activity alongside the main building. The railspur from the southern railway does not appear to extend beyond this area of construction activity. To the southeast, a new facility (Facility-6) is identified.

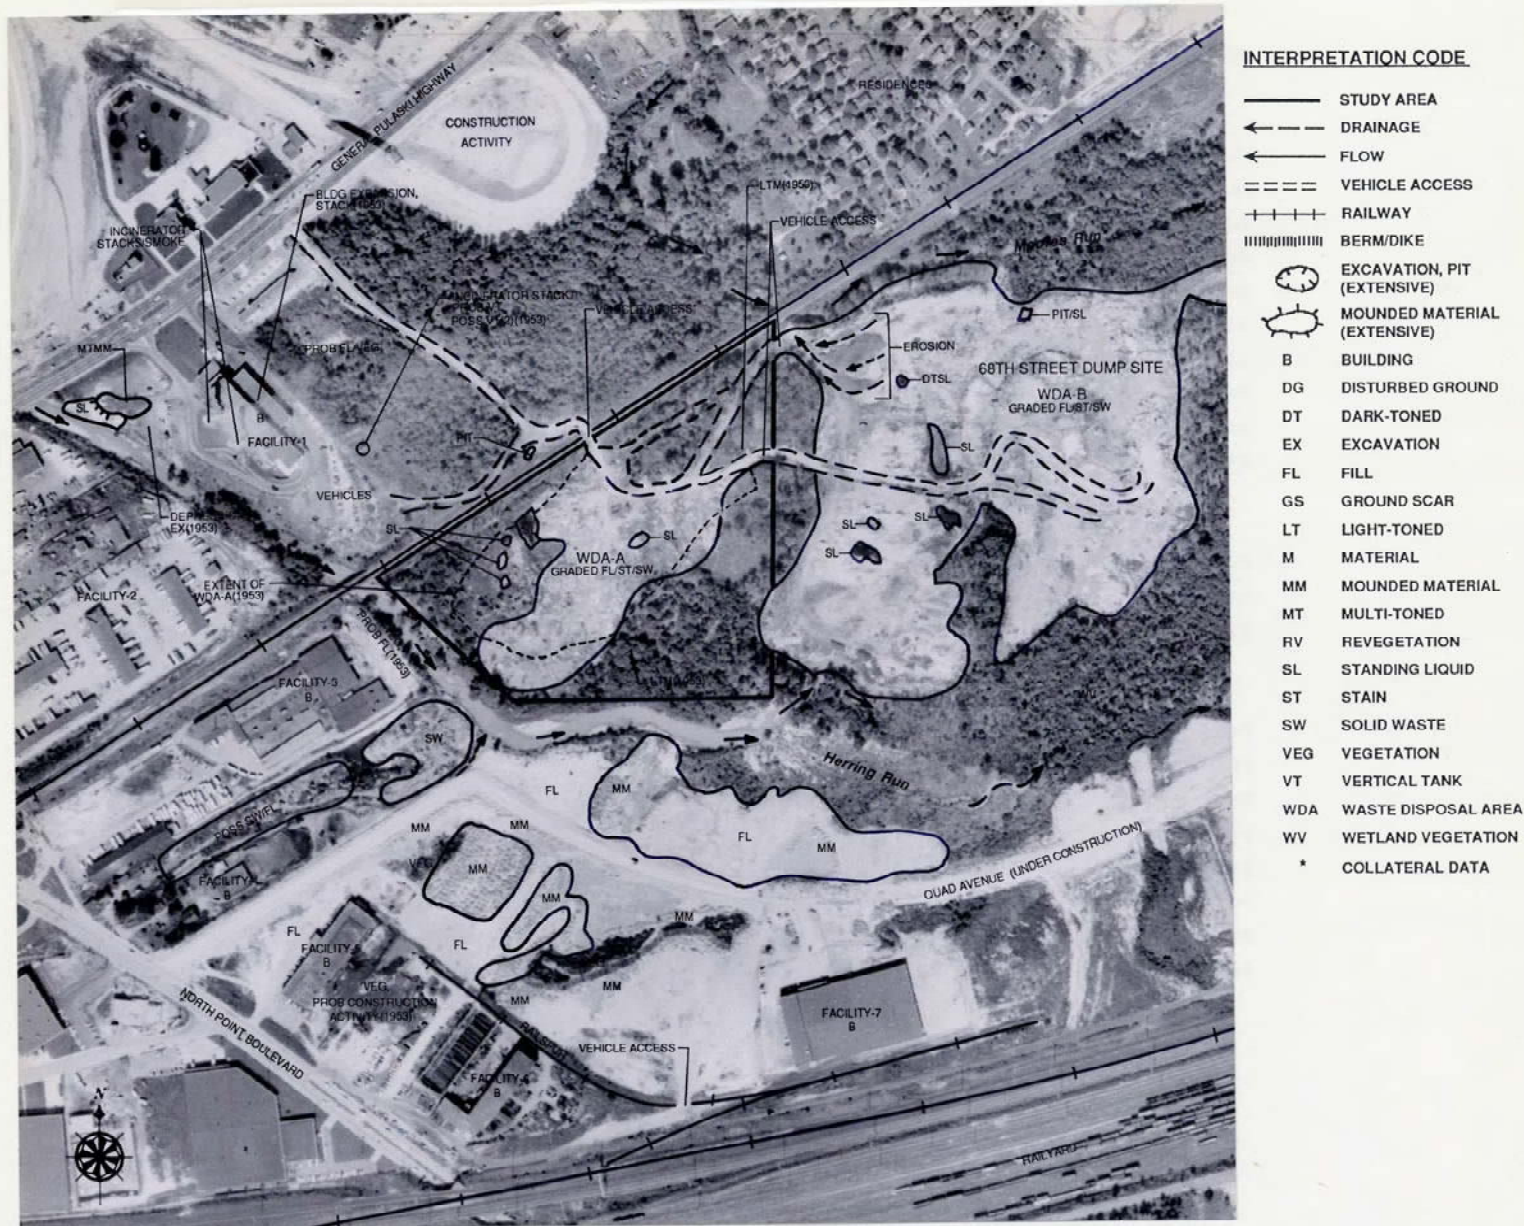
Figure 6. Colgate Pay Dump site, September 25, 1957. Approximate scale 1:4,850.

SEPTEMBER 25, 1957 (FIGURE 6)

Extensive accumulations of graded fill with staining, scattered solid waste, and multiple areas of standing liquids are present at both waste disposal areas (WDA-A and WDA-B). A dashed line represents the former extent of the on-site waste disposal area WDA-A (1953). The northwestern portion of waste disposal area WDA-A now has the appearance of revegetated disturbed ground (not annotated) with multiple areas of standing liquids in a variety of tones. The southwestern portion of waste disposal area WDA-A has been expanded to the northern bank of Herring Run. Waste disposal area WDA-A remains accessible to vehicular traffic (partially annotated) from both Facility-1 to the north and the 68th Street Dump to the east, where waste disposal area WDA-B has undergone extensive expansion (partially annotated). The northern portion of waste disposal area WDA-B includes an area with signs of erosion trending toward Moores Run and a rectangular, liquid-filled pit.

Expansion of the Facility-1 main building has replaced the incinerator stack observed since 1938. Two incinerator stacks have been installed along the western side of the main building. West of the main building, a depression containing mounds of multi-toned materials (MTMM) is seen at the previous location of an excavation (1953). South of the main building, the two possible vertical tanks (1953) are now identified as an incinerator stack and a probable vertical tank. Further south, a pit is present between an unpaved road and the northern railway. At Facility-3 the probable fill observed in 1953 is covered with vegetation and has become confluent with the embankment that bounds this facility. The solid waste area has been expanded to the east at Facility-4. At Facility-5 vegetation is partially covering the area of probable construction activity. North of the southern railspur, extensive areas of graded, light-toned fill and numerous mounds (MM) extend along both sides of Quad Avenue. These construction features (partially annotated) suggest filling will continue or is only partially complete. A new facility (Facility-7) includes a main building and is also serviced by the railspur. To the far northwest, construction activity is noted along General Pulaski Highway.

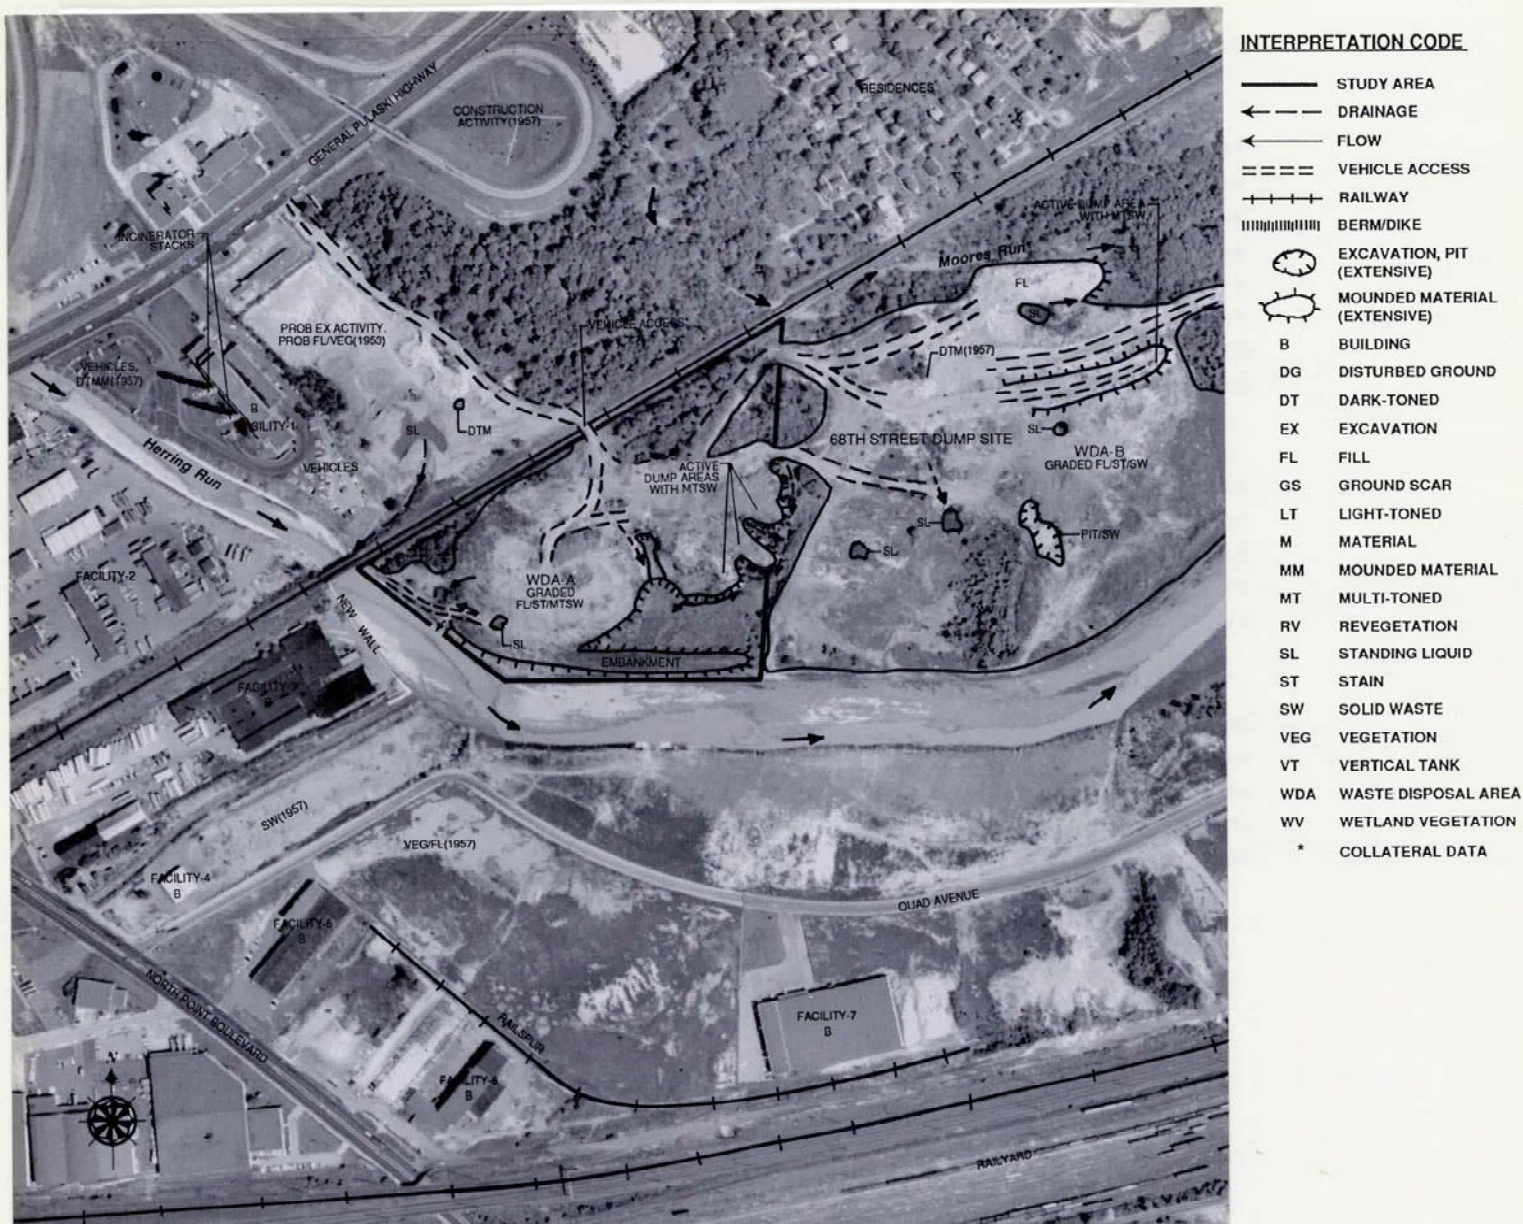
Figure 7. Colgate Pay Dump site, May 18, 1964. Approximate scale 1:4,750.

MAY 18, 1964 (FIGURE 7)

The Colgate Pay Dump site remains accessible to vehicular traffic (partially annotated) from both Facility-1 to the north and the 68th Street Dump to the east. The two waste disposal areas (WDA-A and WDA-B) continue to be comprised of graded, stained, fill material and scattered solid waste. On-site, waste disposal area WDA-A has been expanded to the western, southern, and eastern site boundaries. At waste disposal area WDA-A, surface drainage from an area with standing liquid trends downhill to Herring Run, which has been channelized since 1957, and toward an unpaved vehicle access road. A linear embankment extends along a portion of the western site boundary and the entire southern site boundary. Active dumping of multi-toned solid waste (MTSW) is evident in the southern portion of waste disposal area WDA-A.

Off-site, waste disposal area WDA-B has been expanded to the northern bank of Herring Run, and is approaching the bank of Moores Run; active dumping of multi-toned solid waste is also seen; and includes an irregularly shaped pit with solid waste and multiple areas of standing liquid.

Since 1957 the vegetation in the area northeast of the Facility-1 main building has been removed. At this area, probable excavation activities are ongoing and include an expanse of standing liquid and an area with dark-toned material. Parked vehicles have replaced the mounds of dark-toned materials previously seen west of the main building. At Facility-3, a wall has been installed along the bank of Herring Run. At Facility-4, the solid waste has been removed and a new building has been installed. Construction of Quad Avenue appears to have been completed and vegetative growth is apparent (not annotated) on the fill areas along both sides of this roadway.

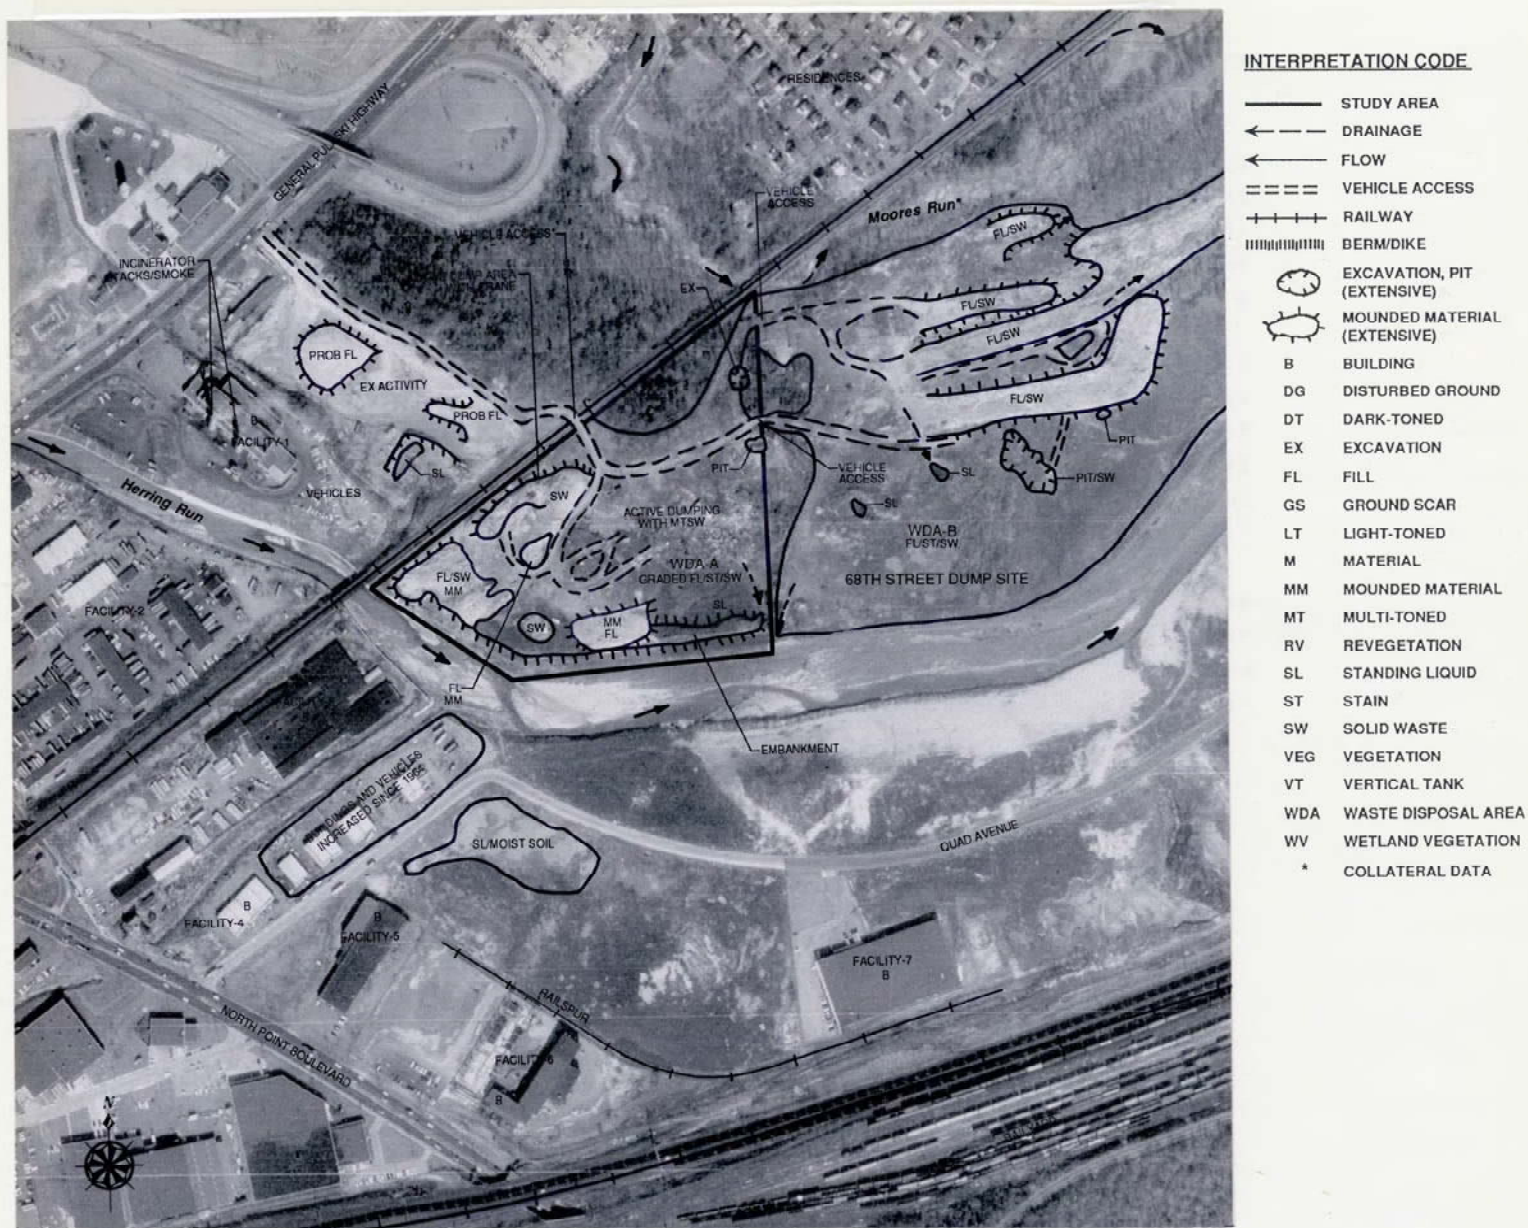
FEBRUARY 21, 1966 (FIGURE 8)

Since 1964 both waste disposal areas (WDA-A and WDA-B) have been expanded in areal extent. On-site at waste disposal area WDA-A, an active dumping area with a crane (not individually annotated); areas with fill material and solid waste (spread-out and mounded); standing liquid; a pit; and a circular excavation are present. Active dumping of multi-toned solid waste remains evident in the southeastern portion of waste disposal area WDA-A. Along the eastern boundary of the Colgate Pay Dump site, the two waste disposal areas are difficult to differentiate due to the spreading of the solid waste and fill material.

Off-site at waste disposal area WDA-B, areas with standing liquid and the irregularly shaped pit with solid waste are still present. Since 1964 mounds comprised of fill material and solid waste have been established north of the irregularly shaped pit. Vehicle access extends from the irregularly shaped pit to the southernmost mound. To the east, a smaller pit is present alongside this mound.

At Facility-1 smoke emissions are visible from the two incinerator stacks. East of the main building, excavation activities continue and there are two extensive mounds of probable fill material. A berm partially impounds the standing liquid. At Facility-4 the number of buildings and vehicles has increased (not individually annotated). An area with standing liquid and moist soil is present between Quad Avenue and Facility-5.

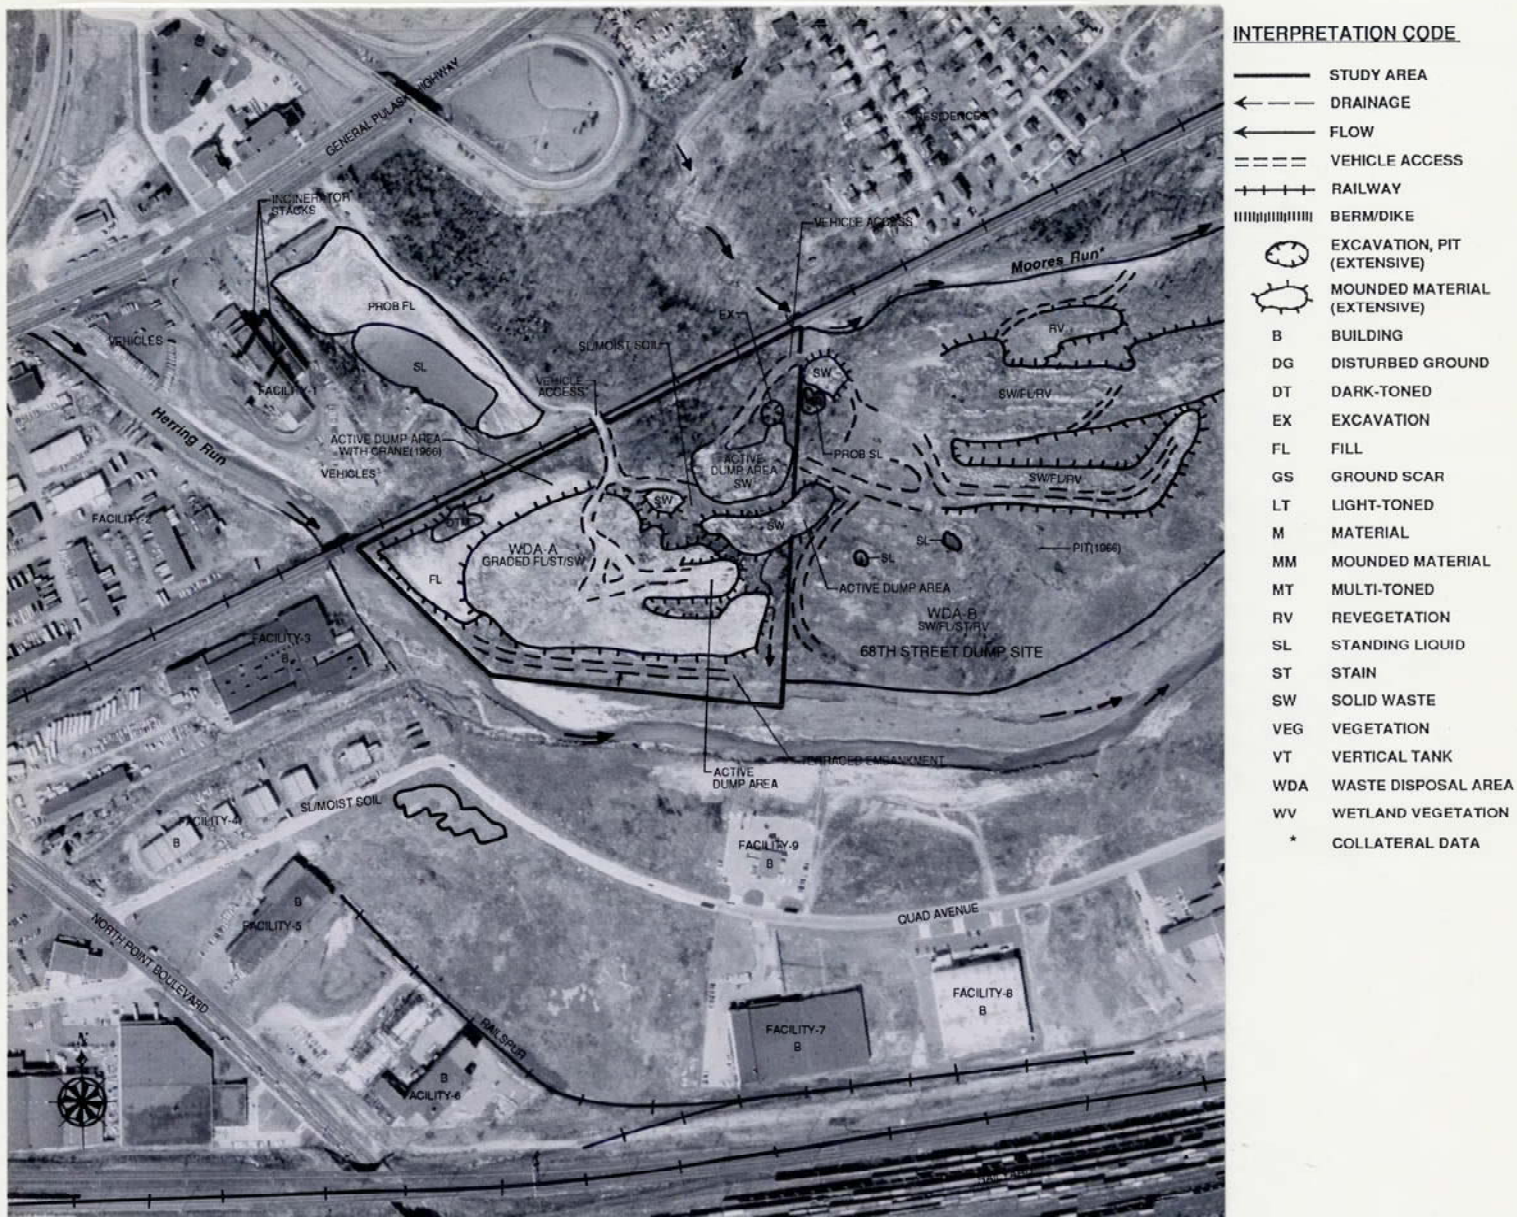
Figure 9. Colgate Pay Dump site, March 5, 1969. Approximate scale 1:4,780.

MARCH 5, 1969 (FIGURE 9)

On-site, active dump areas are evident in the southeastern and eastern portions of waste disposal area WDA-A. Due to the increased height of the materials in waste disposal area WDA-A, the embankment feature observed since 1964 now appears terraced. Waste disposal area WDA-A has been expanded to all boundaries of the site and appears to have merged with waste disposal area WDA-B east of the Colgate Pay Dump.

Off-site, the northern boundary of waste disposal area WDA-B extends to the bank of Moores Run, and the southern boundary to the bank of Herring Run. Areas with standing liquid remain visible. Revegetating mounds comprised of fill material and solid waste are also visible. Vehicle access extends from the northernmost mound to the southern bank of Moores Run.

East of the Facility-1 main building, the probable fill area has been expanded. The areal extent of the standing liquid has increased substantially since 1966. An area with standing liquid and moist soil remains present between Quad Avenue and Facility-5. Two new facilities (Facility-8 and Facility-9) are identified on either side of Quad Avenue.

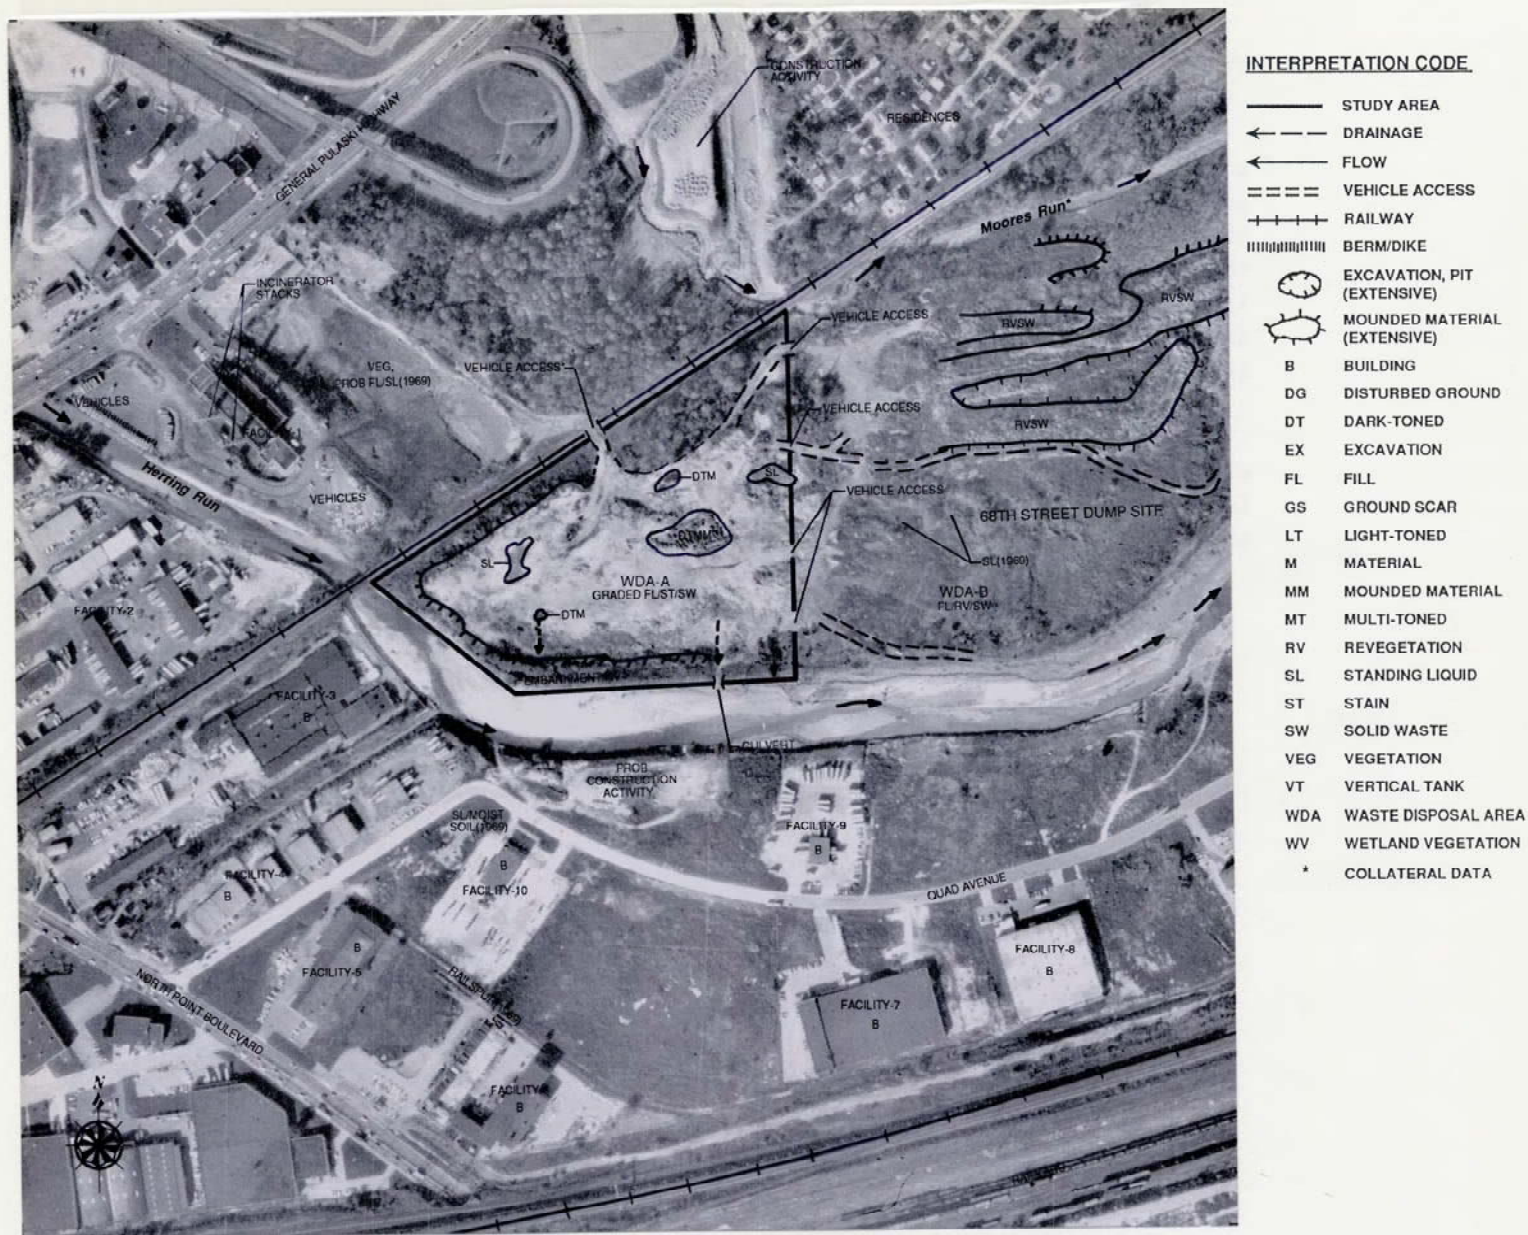
Figure 10. Colgate Pay Dump site, November 5, 1971. Approximate scale 1:4,730.

NOVEMBER 5, 1971 (FIGURE 10)

On-site, waste disposal area WDA-A continues to cover the entire site. The ground surface appears heavily stained and there are areas with standing liquid and mounds of dark-toned materials. Along the southern site boundary, the terraced embankment is now heavily vegetated and a culvert is present. Along the eastern site boundary, waste disposal area WDA-A is not readily distinguishable from waste disposal area WDA-B off-site.

At waste disposal area WDA-B the revegetating mounds comprised of fill material and solid waste remain visible. Areas with standing liquid are not visible in this portion of waste disposal area WDA-B.

At Facility-1 the previously observed standing liquid is not visible. It is possible the area covered by the standing liquid was filled in, since the tone of the fill material in this vicinity was previously light-toned and now appears to be medium-toned. At Facility-9 development has extended to the southern bank of Herring Run and numerous vehicles are present. A new facility (Facility-10) is noted northeast of Facility-5, where standing liquid and moist soil were observed in 1969. To the north along the bank of Herring Run, probable construction activity is observed. Northeast of the site and across the northern railway, construction activity is noted associated with the northern portion of Moores Run.

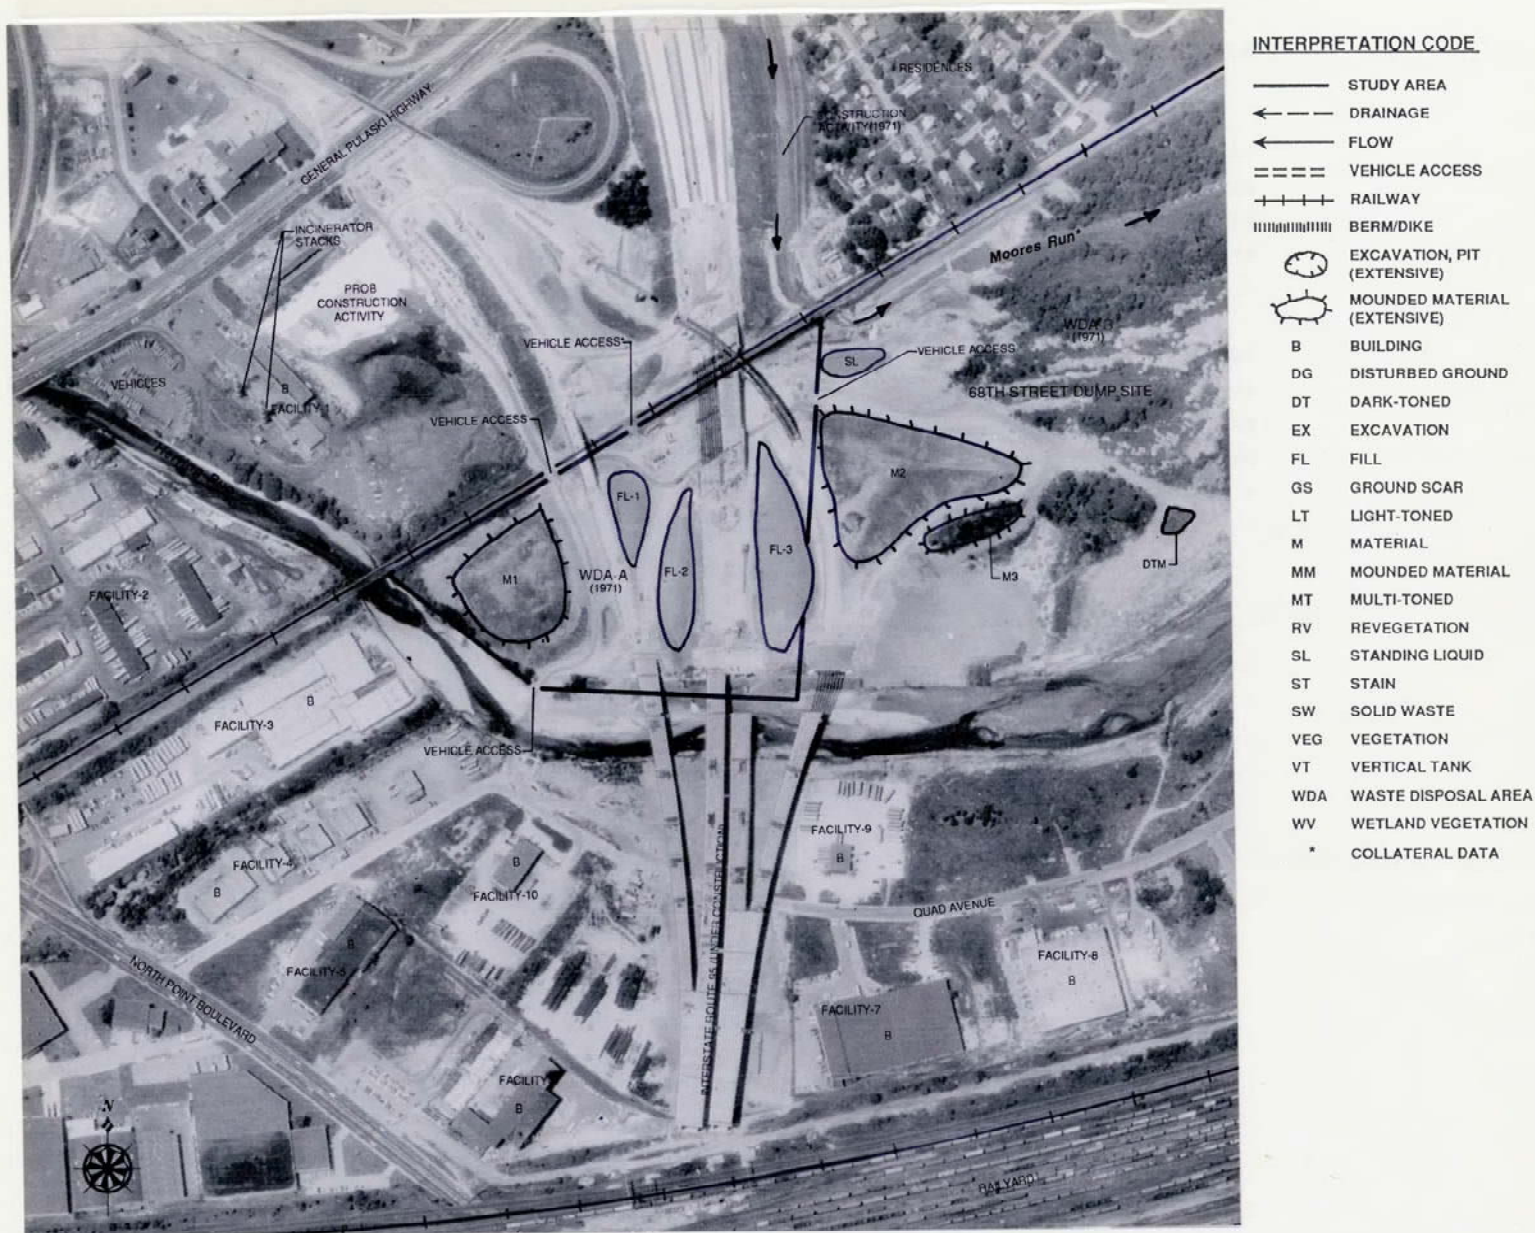
Figure 11. Colgate Pay Dump site, June 14, 1973. Approximate scale 1:4,680.

JUNE 14, 1973 (FIGURE 11)

Activities associated with the construction of Interstate 95 obscure much of the Colgate Pay Dump site, the northeastern portion of Facility-1, and the portion of the 68th Street Dump site identified as waste disposal area WDA-B. Three light-toned areas (FL-1 through FL-3) of probable fill material within the road construction activity area are identified for locational purposes. Light-toned fill material covers much of the ground surface previously utilized as waste disposal areas (WDA-A and WDA-B). An extensive, dark-toned mound (M1) is present in the southwestern portion of the site.

A second, similar mound (M2) is present outside the eastern site boundary along with a smaller, vegetated mound (M3). An area with standing liquid is located north of mound M2. An area with dark-toned material is located east of mound M3. Probable construction activity is noted at Facility-1.
